Building Inspection Report

345 My Home Circle, Serendipity, Alaska, 99000

10/04/2000

Certified Home Inspection Services

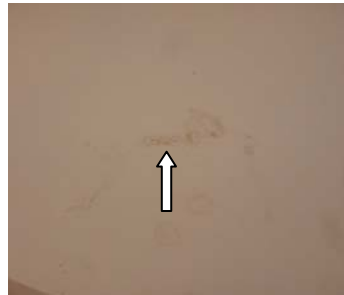
- **Monitor:** Signs of mold were observed on the insulation bulkhead at the attic access scuttle. Seal attic access.
- **Monitor:** Water staining was noted on ceiling. Investigate source in attic. .

Moisture stains on ceiling

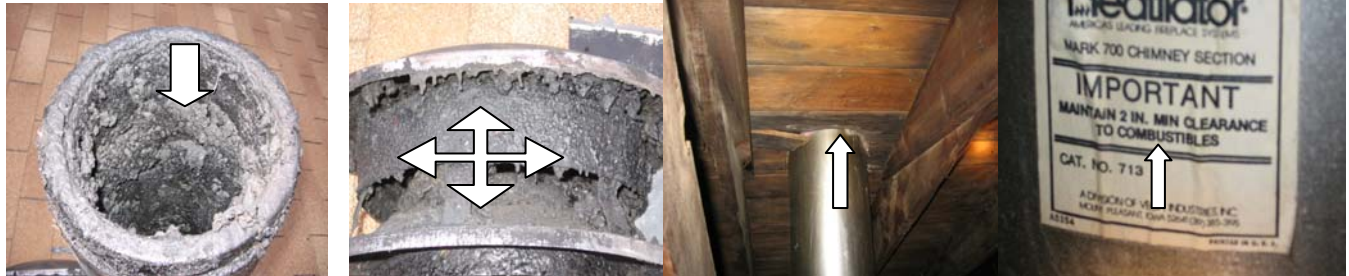
- **Safety Issue, Repair, and Service:** Accumulation of creosote in wood stove stack. Have stack cleaned prior to use.
- **Safety Issue, Repair:** The wood stove stack clearance to combustibles is less than the 2 inch minimum per manufacturers' label.
- **Monitor:** Recommend evaluation and service by an appropriate technician **prior** to use.

Creosote in wood stove stack.

Zero clearance to combustibles Mfgs. Label is two inches
